PROPERTY CONDITION ASSESSMENT
OF
WORLD TRADE CENTER PORTFOLIO

ONE WORLD TRADE CENTER

Re: Due Diligence Physical Condition Survey
World Trade Center
New York, New York

REPORT OF
DUE DILIGENCE PHYSICAL CONDITION SURVEY
WORLD TRADE CENTER

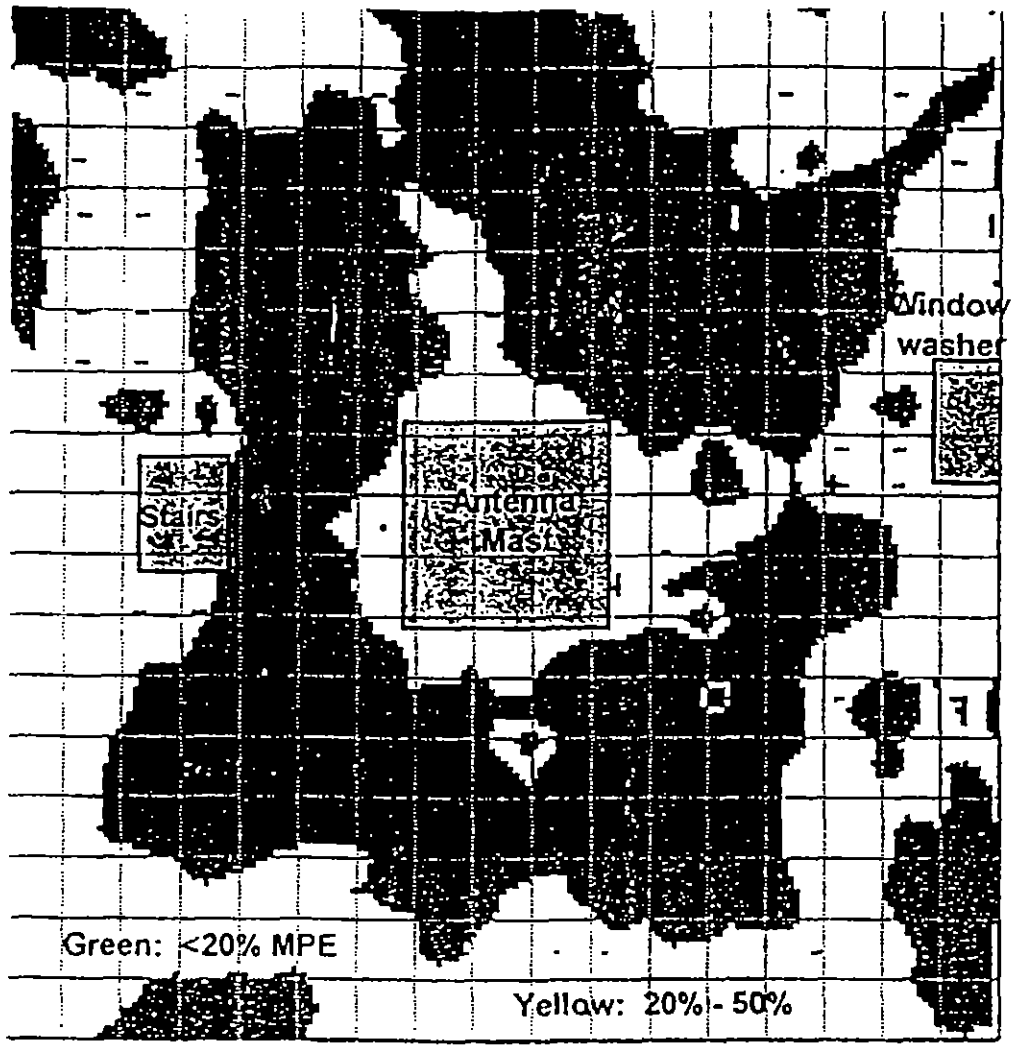
If the contribution of the 72 MHz paging links is removed, in a fashion like that described above, the resulting roof map, shown in Figure 13, shows that the maximum RF field level has been reduced from 147% of the MPE to 138% and the extent of the roof area that is subject to fields exceeding the lower, general public MPE is slightly decreased to 94.3% of the roof surface. This condition projects the expected ambient RF field levels

Figure 13. Roof map of RF fields during tower maintenance mode with contribution of 72 MHz paging links removed with RoofView Maximum field is 138.3% MPE

Statistical summary of RF Fields on WTC roof (see Figure 13)		
Percent occupational MPE range (%)	Roof area in this range (ft^2)	Percent of roof area in this range (%)
0-20	1546	5.68
21-50	13108	48.18
51-100	12035	44 24
>100	516	1 90

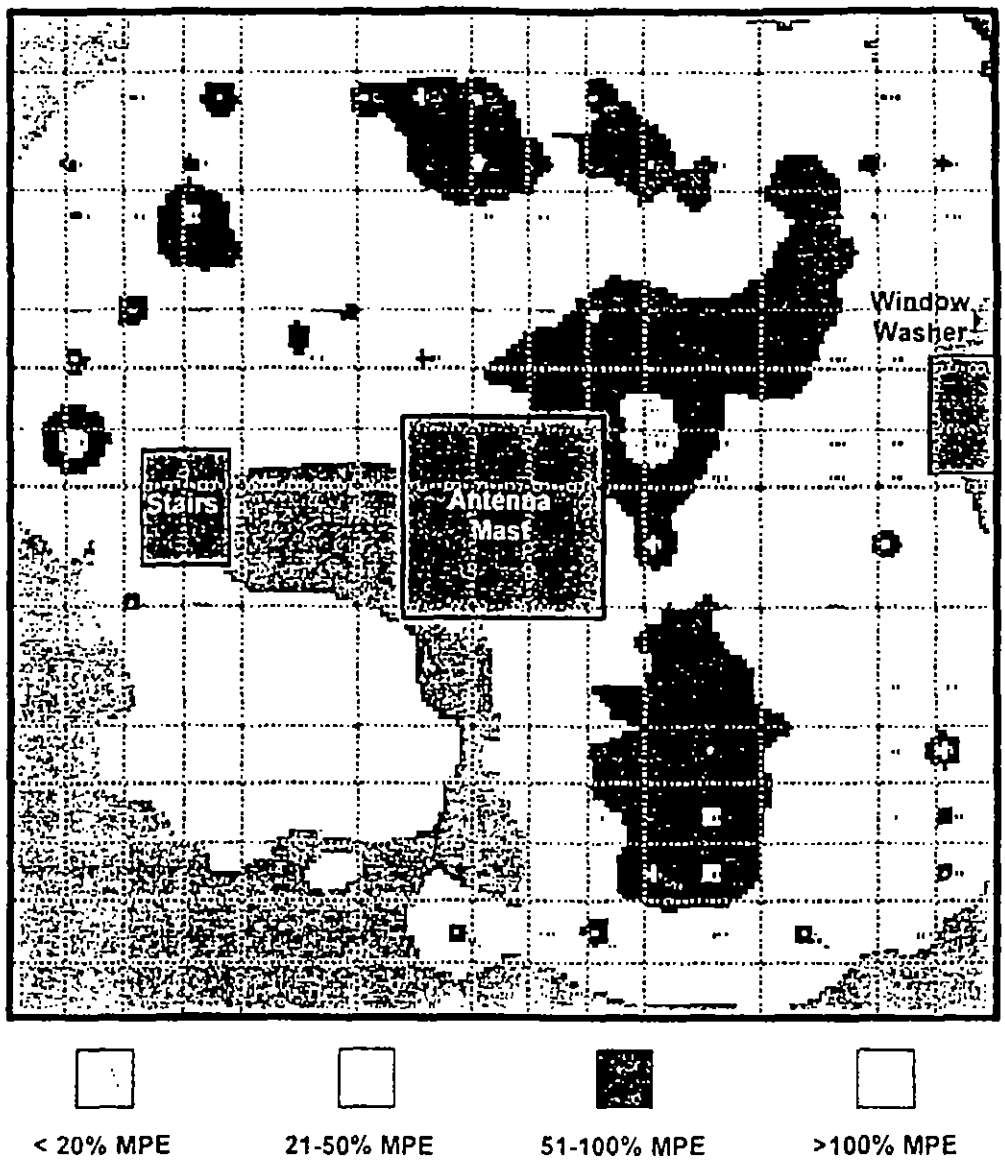
Figure 1. 1999 reevaluation of RF fields from measured ambient fields of normal broadcasting operations with calculated contribution of all wireless telecommunications antennas. Maximum field is 299.6% MPE.

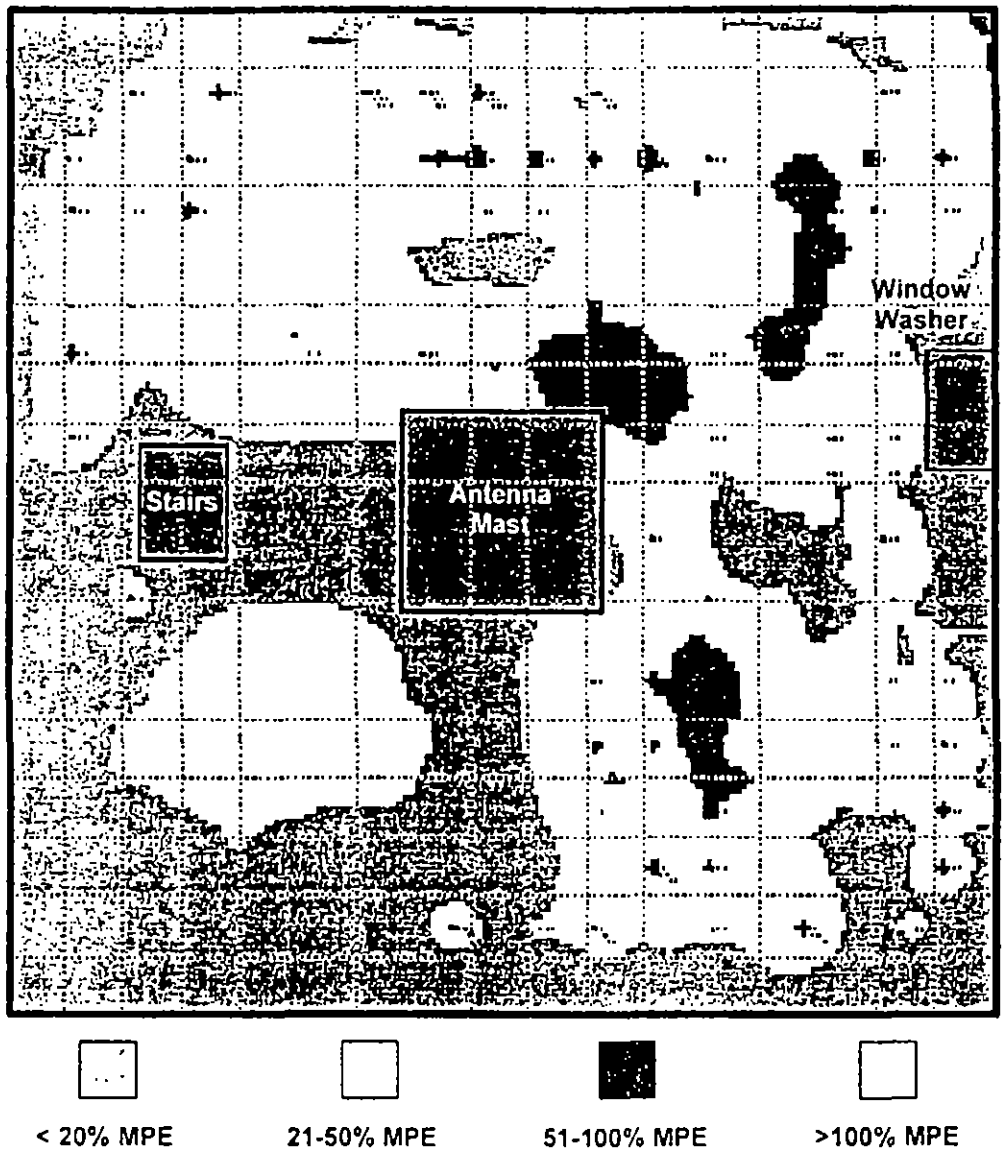
Figure 2. 1999 reevaluation of RF fields from measured ambient fields of normal broadcasting operations with calculated contribution of all wireless telecommunications antennas with selected antennas raised to eliminate fields exceeding MPE. Maximum field is 77.5% MPE.

1999 Statistical summary of RF Fields on WTC roof		
Percent occupational MPE range (%)	Roof area in this range (ft^2)	Percent of roof area in this range (%)
0-20	9810	36.06
21-50	16232	59.67
51-100	1163	4.27
>100	0	0.00

Elevating certain antennas on the roof will tend to reduce local fields in the near vicinity of those antennas. While this approach to roof level field mitigation can be effective, personnel training in RF safety issues, the use of personal RF monitors and instigation of specific work practices may prove as effective, and more practical, for insuring compliance with FCC RF exposure rules.

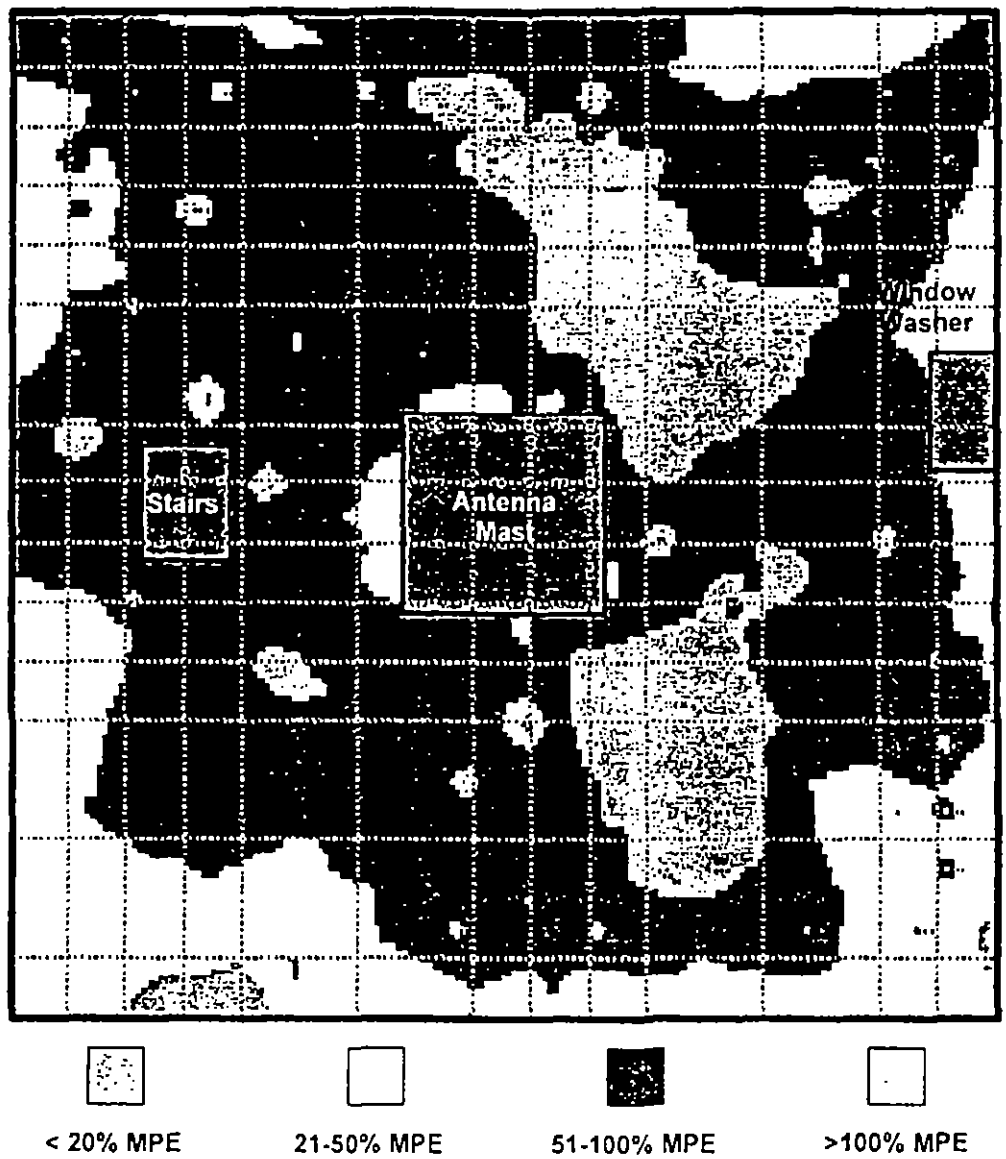
Figure 3. 1999 reanalysis of RF fields from measured ambient fields of tower maintenance broadcasting operations with calculated contribution of all wireless telecommunications antennas. Maximum field is 333.5% MPE.

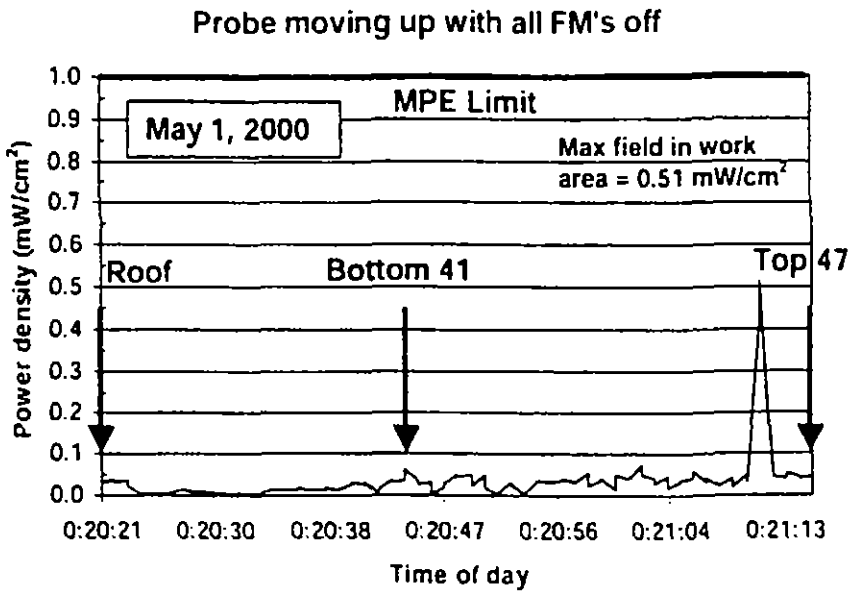
working area with the FM stations off. During the measurements, it was noted, as shown in Figure 22, that near the top of the channel 47 aperture, a narrow spike in the power density profile was observed. It is not apparent why this was observed but, in any event, the magnitude of the spike was less than 1 mW/cm^2, the MPE limit in the FM broadcast band. The most likely source of this narrow peak in field would be the channel 31 antenna that operates at 2,820 kW of ERP at 572 MHz where the MPE limit is 1.9 mW/cm^2. Thus, this value, while not clear what the source was, is less than the MPE for either the FM band or the UHF spectrum.

Figure 22. Plane wave equivalent power density measured parallel to antenna mast on May 1, 2000, with normal broadcast operations but with all FM stations off and probe moving up.

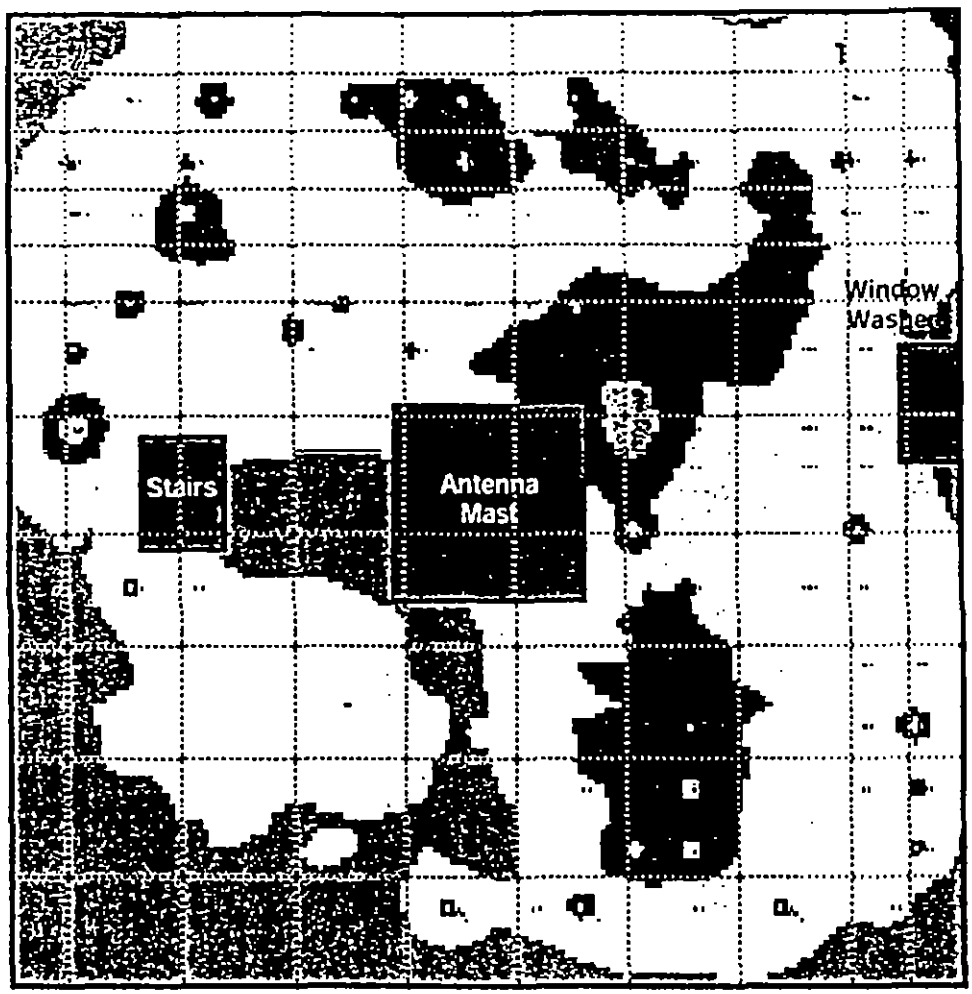
A 1999 reevaluation of RF fields from measured ambient fields of normal broadcasting operations with calculated contribution of all wireless telecommunications antennas (see footnote on page 10). Maximum field is 299.6% MPE.

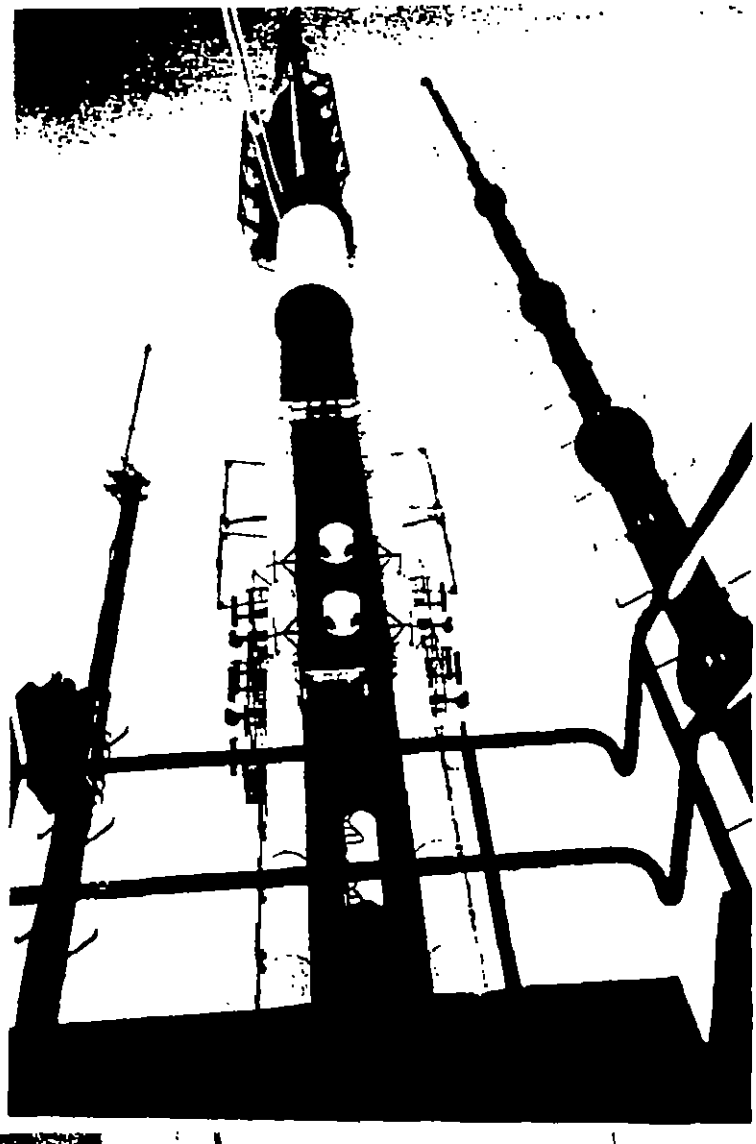
Photo #1:
360-Foot antenna mast on One World Trade Center.

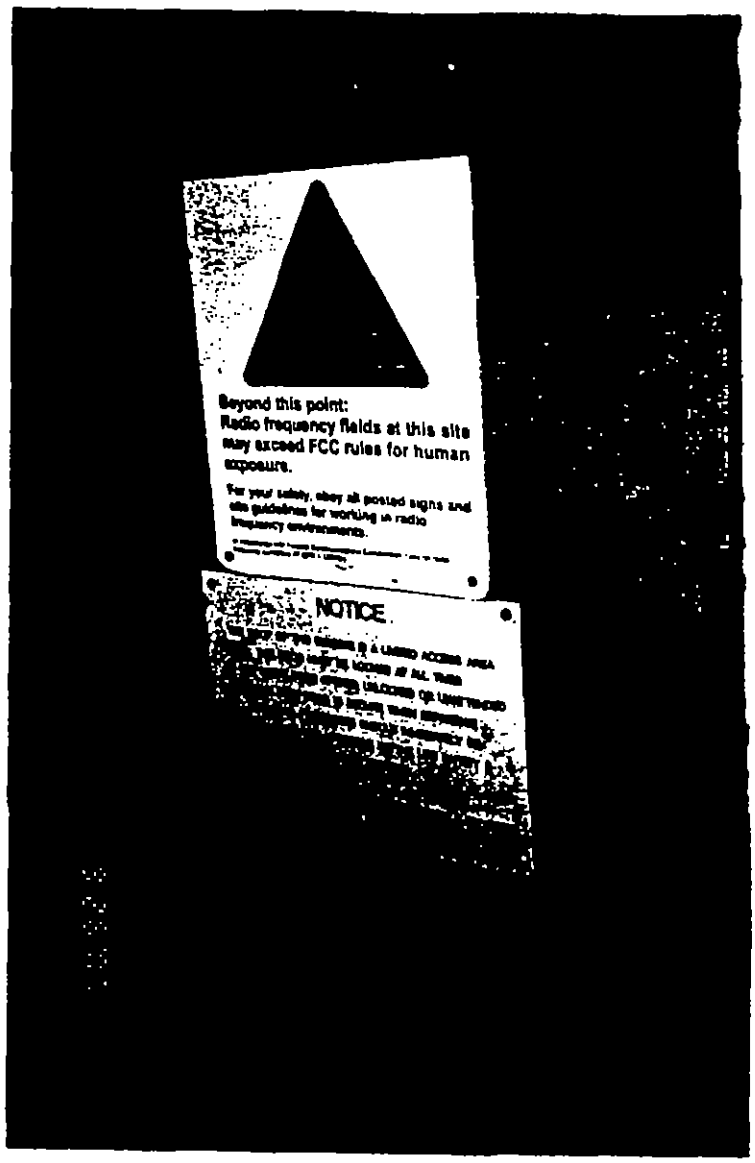
Photo #5: Signage at door to roof – One World Trade Center.

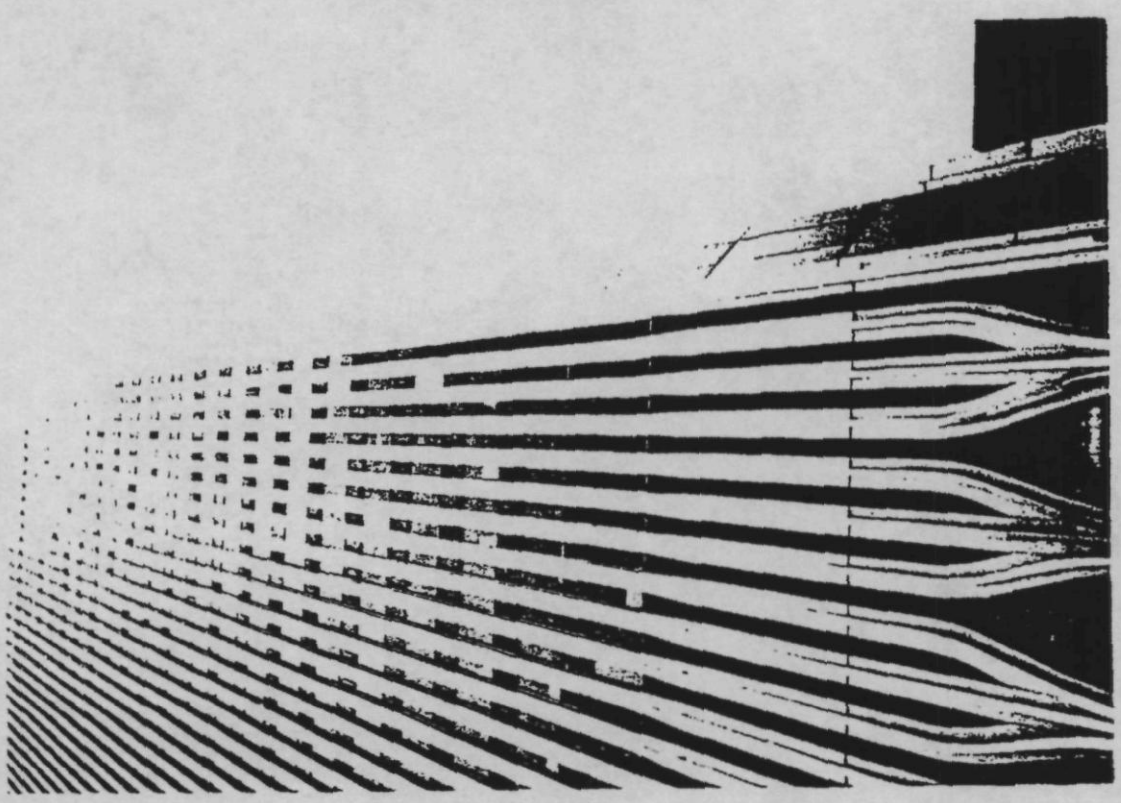
1

B. The curtain wall system consists of vertical strip windows set between tightly spaced aluminum clad building columns (Refer to photographs 1, 2 and 3). Within the vertical strip windows, aluminum spandrel panels occur at each floor line. Aluminum panels are used to clad the four chamfered corners of the tower and the sloped parapet of the main roof (Refer to photograph 3). The finish on the curtain wall framing, aluminum column cladding, corner panels and parapet panels is a clear or natural anodize. The finish on the spandrel panels is darker and could be a light bronze anodized finish.
